(Final Report, Revised January 15, 2016)
**Condition Assessment
&
Reserve Fund Plan Update
2016
KINGS PARK WEST**

Fairfax, Virginia

RE: **CONDITION ASSESSMENT AND RESERVE FUND PLAN UPDATE 2016**
Park West Community Association/Kings Park West
(Final Report, Revised January 15, 2016)
Fairfax, Virginia
Project No. 7993

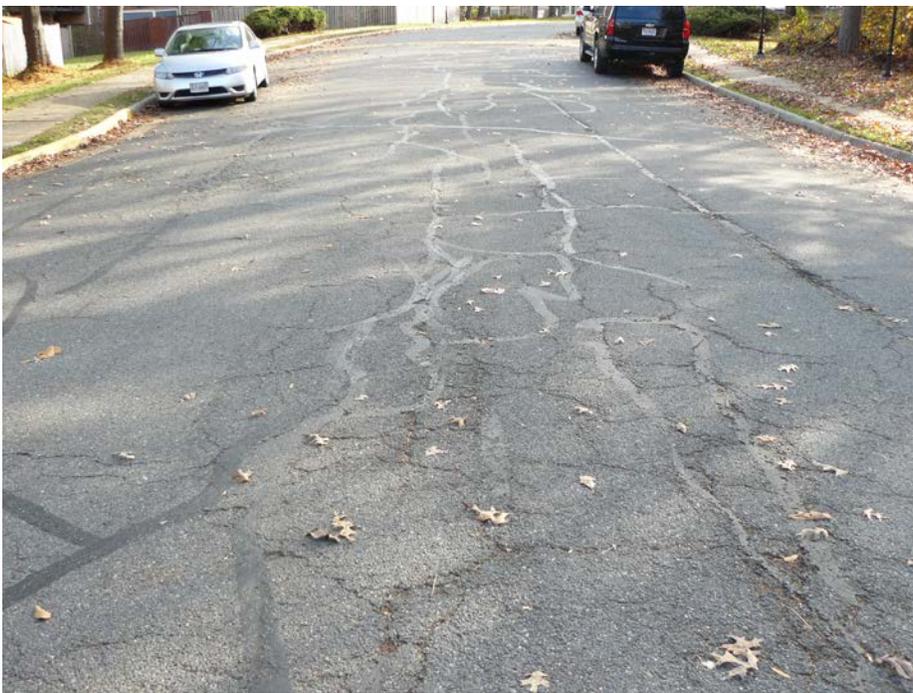
PHOTO #1
The asphalt driveways and parking bays range from poor to fair condition. They have reached the end of their service lives and require near-term restoration.

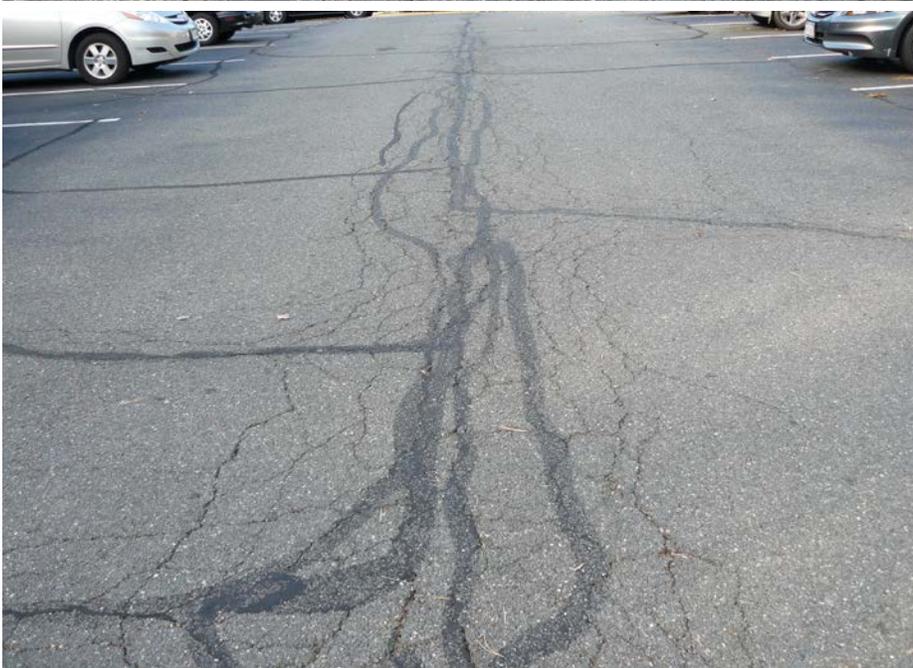
PHOTO #2
All deflected pavement, such as this requires full-depth repair prior to overlay. Crack filling deflected asphalt is not a proper repair.

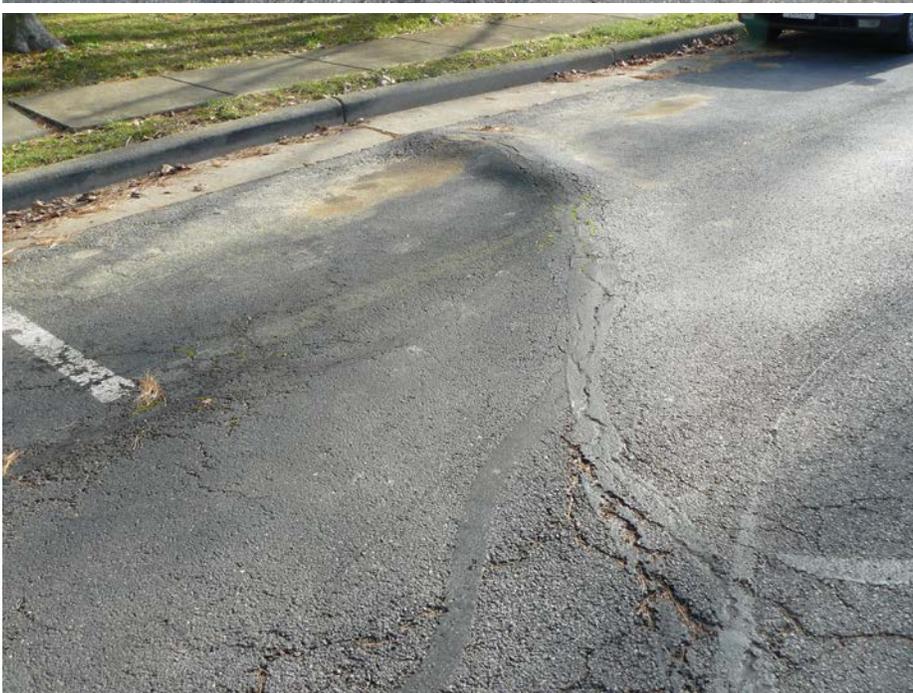
PHOTO #3
Treasure Court will require tree root removal prior to restoration.

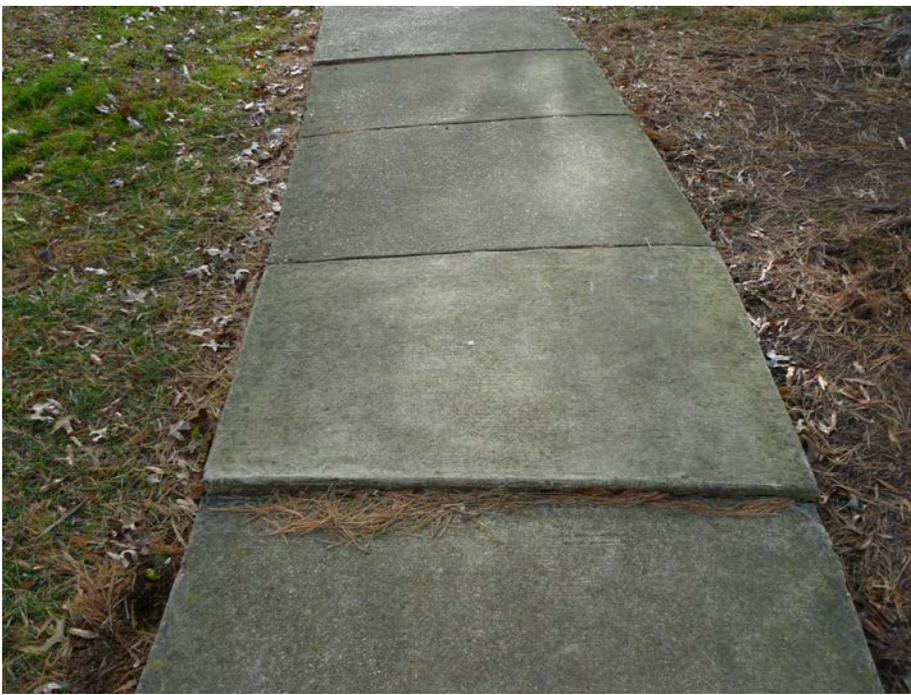
PHOTO #4
A significant amount of settled concrete panels were observed throughout the community. These are potential tripping hazards and should be repaired/replaced near-term.

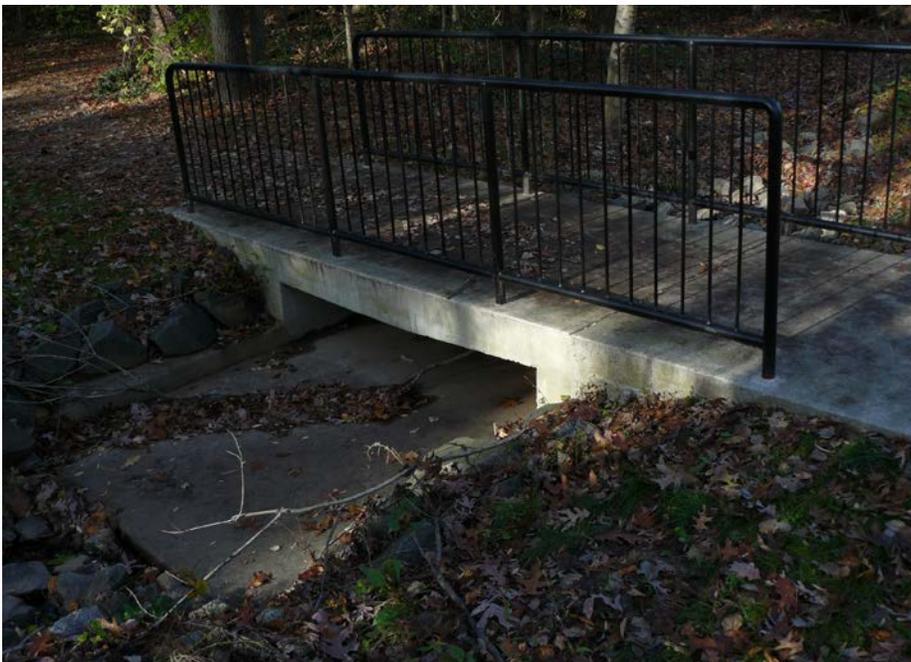
PHOTO #5
A concrete bridge and metal handrailings have been constructed at the creek crossing near the tot lot. A second concrete bridge will be constructed near-term on the path near the pool.

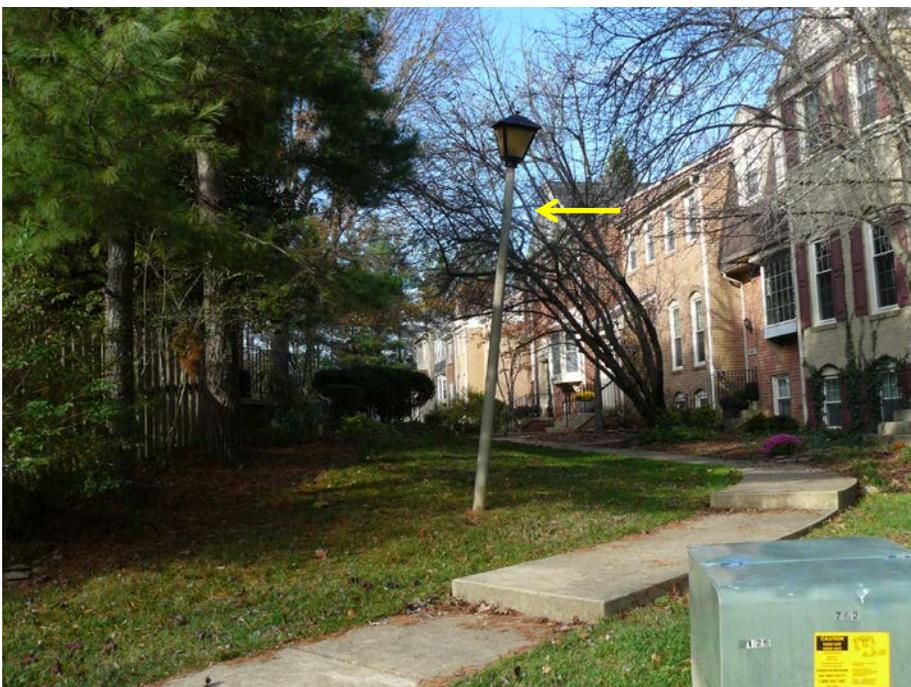
PHOTO #6
We understand that the street light fixtures have been re-lamped with L.E.D. Any poles out of plumb should be straightened.

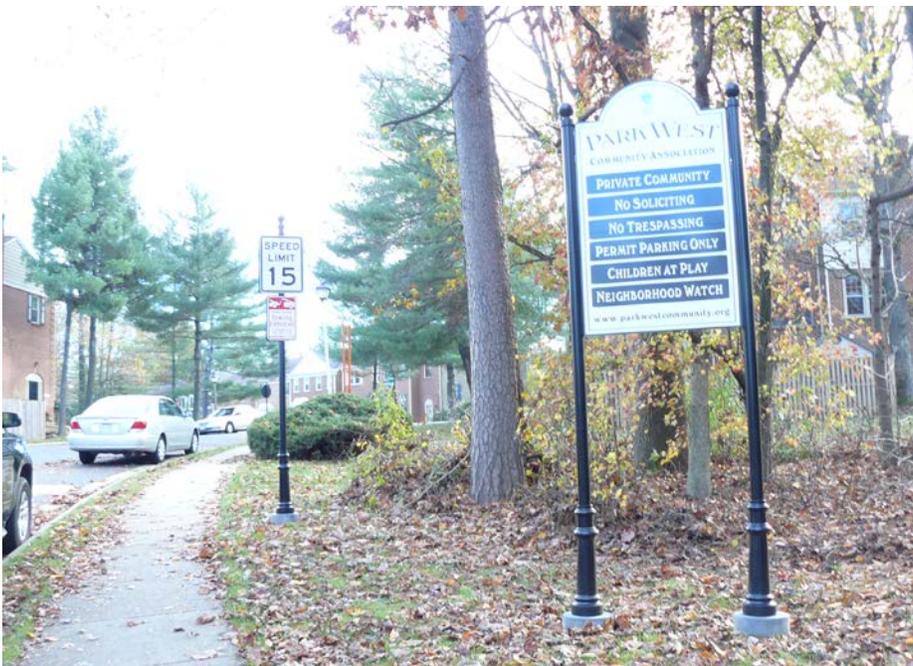
PHOTO #7
All of the street and informational signs have been replaced recently with high quality custom signs.

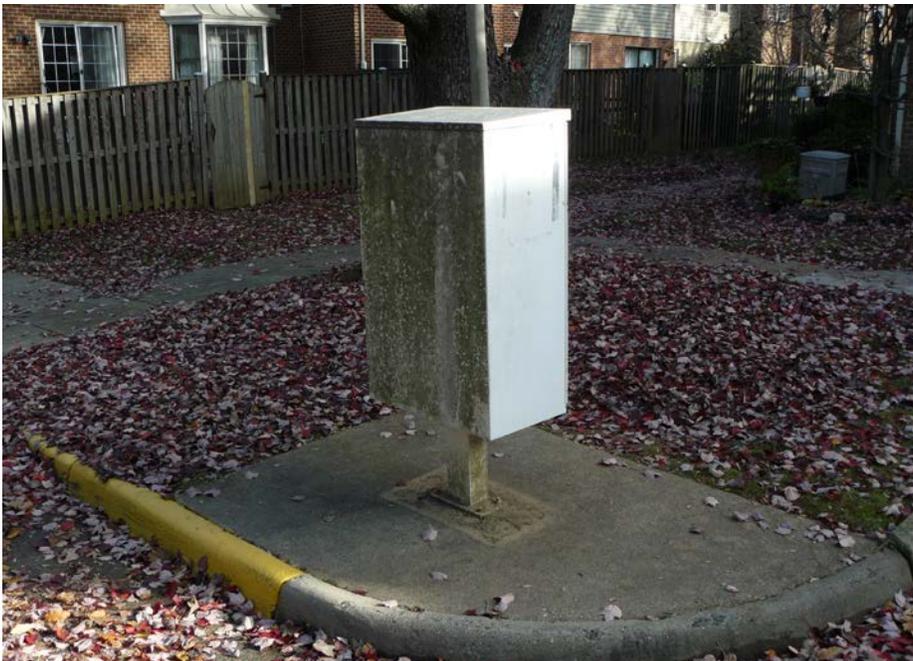
PHOTO #8
We understand that the Board would like to replace all of the mailbox modules near-term.

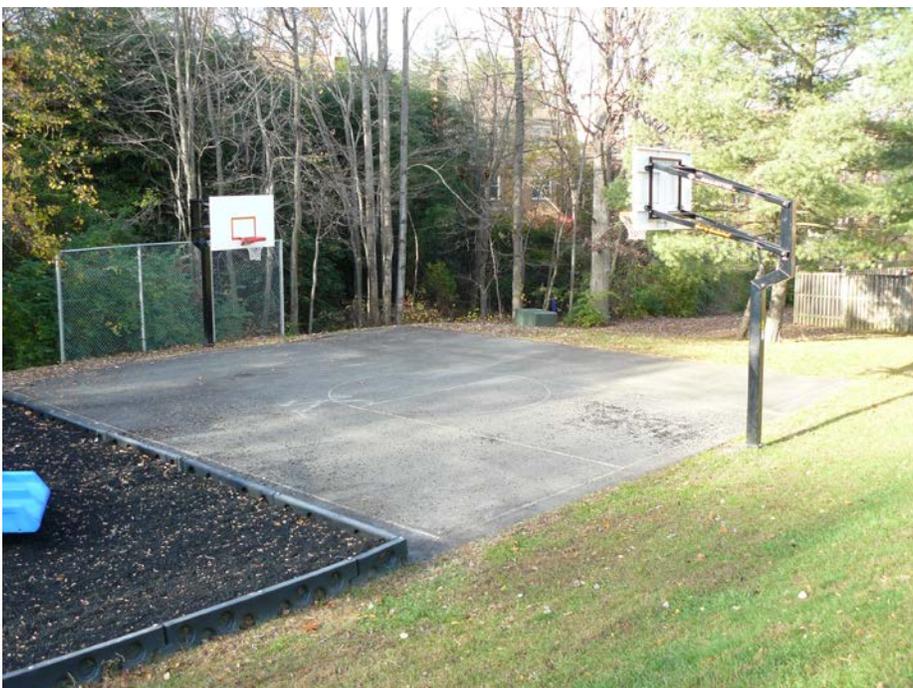
PHOTO #9
The multi-purpose court, basketball goals, and the chain link fencing are in continuing good condition. The rubber mulch on the court will provide a much longer service life than wood chips.

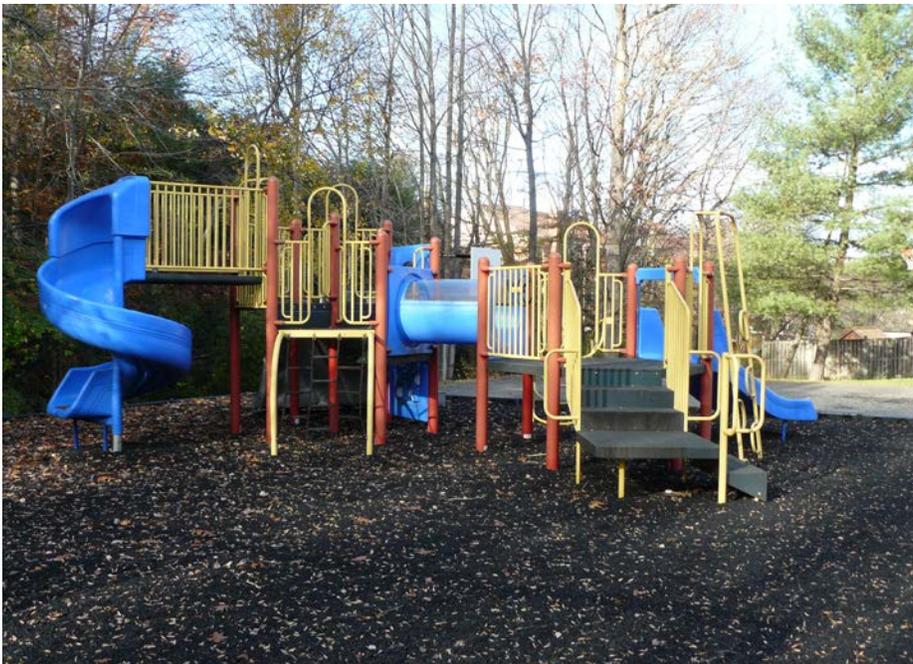
PHOTO #10
The tot lot components range from fair to continuing good condition. The steps of the play module are rusting and should be monitored for safety.

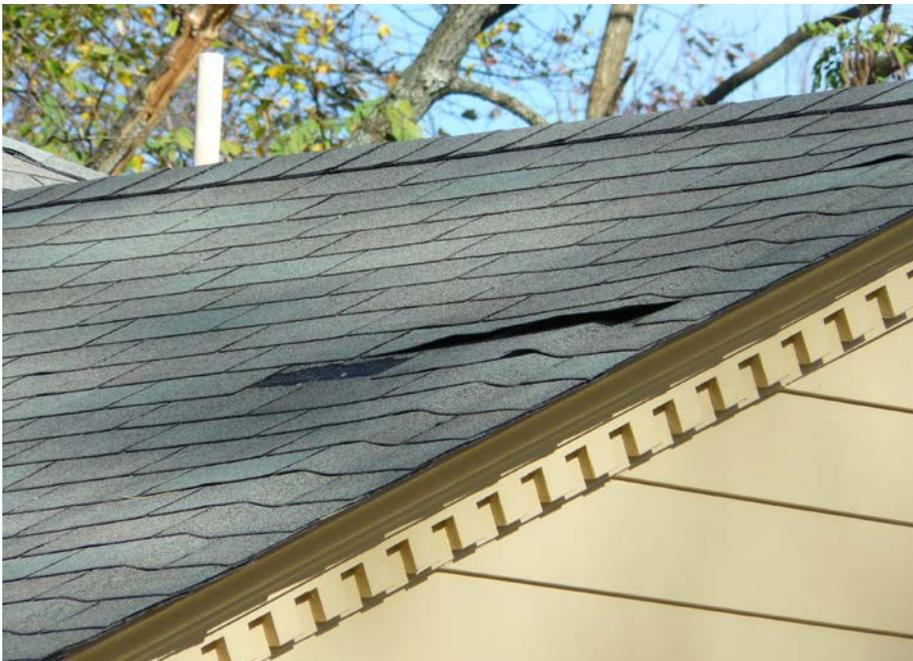
PHOTO #11
The three-tab asphalt shingle roofing of the pool building has reaching the end of its service life and requires re-roofing near-term. The wood trim and siding appear to be in continuing good condition.

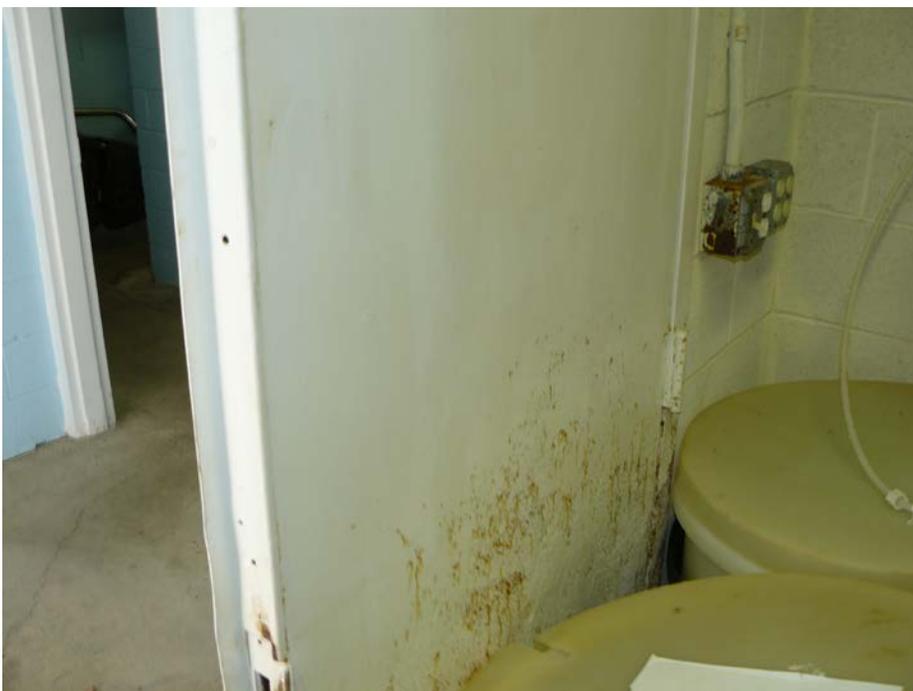
PHOTO #12
Some of the steel doors in the pool building are deteriorated, requiring near-term replacement.

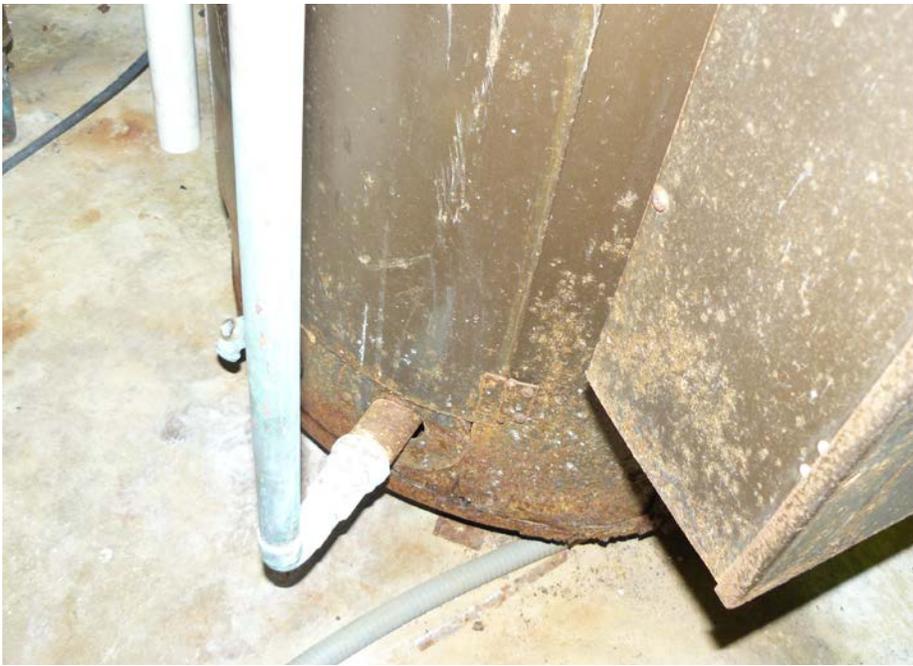
PHOTO #13

The water heater has been in service for many years. Although it is still in serviceable condition, it may require replacement soon. We suggest it be relocated out of the pump room when it is replaced.

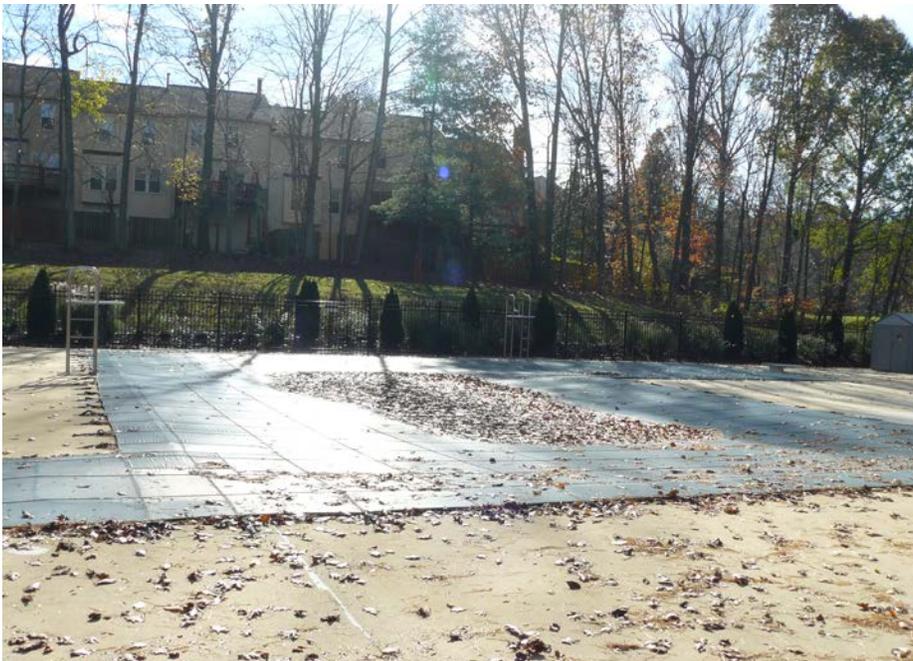
PHOTO #14

The pool covers and the pool deck ranges from fair to continuing good condition. We could not evaluate the pool coping or the white coating.

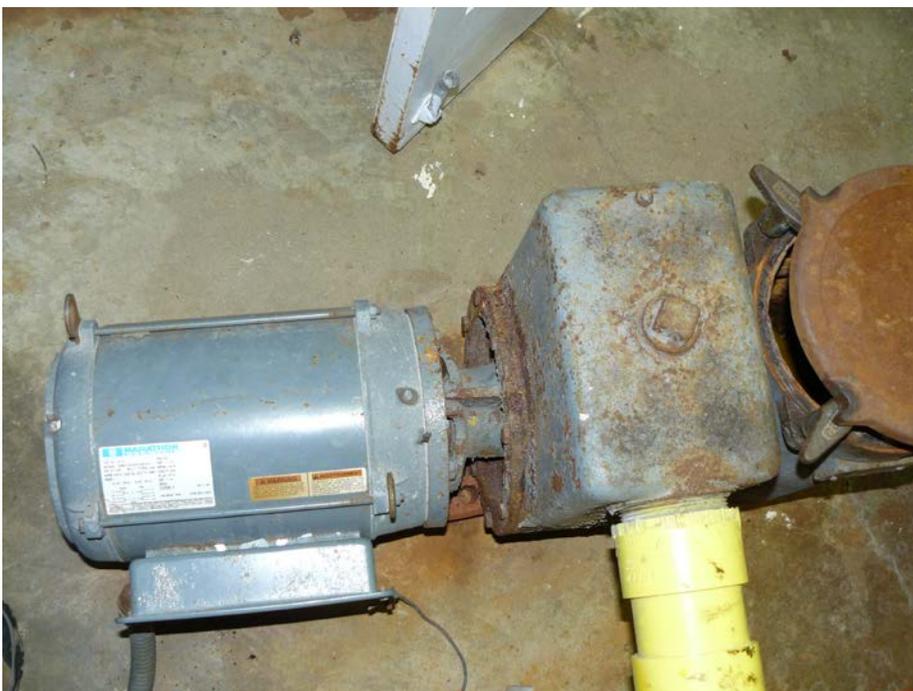
PHOTO #15

The main pool pump and strainer assembly have been in use for many years. No problems were reported, but may require replacement soon.
